LAKE COUNTY 1989 TRAFFIC SAFETY STUDY

LAKE COUNTY

TRAFFIC SAFETY IMPROVEMENT

SEPTEMBER 1989

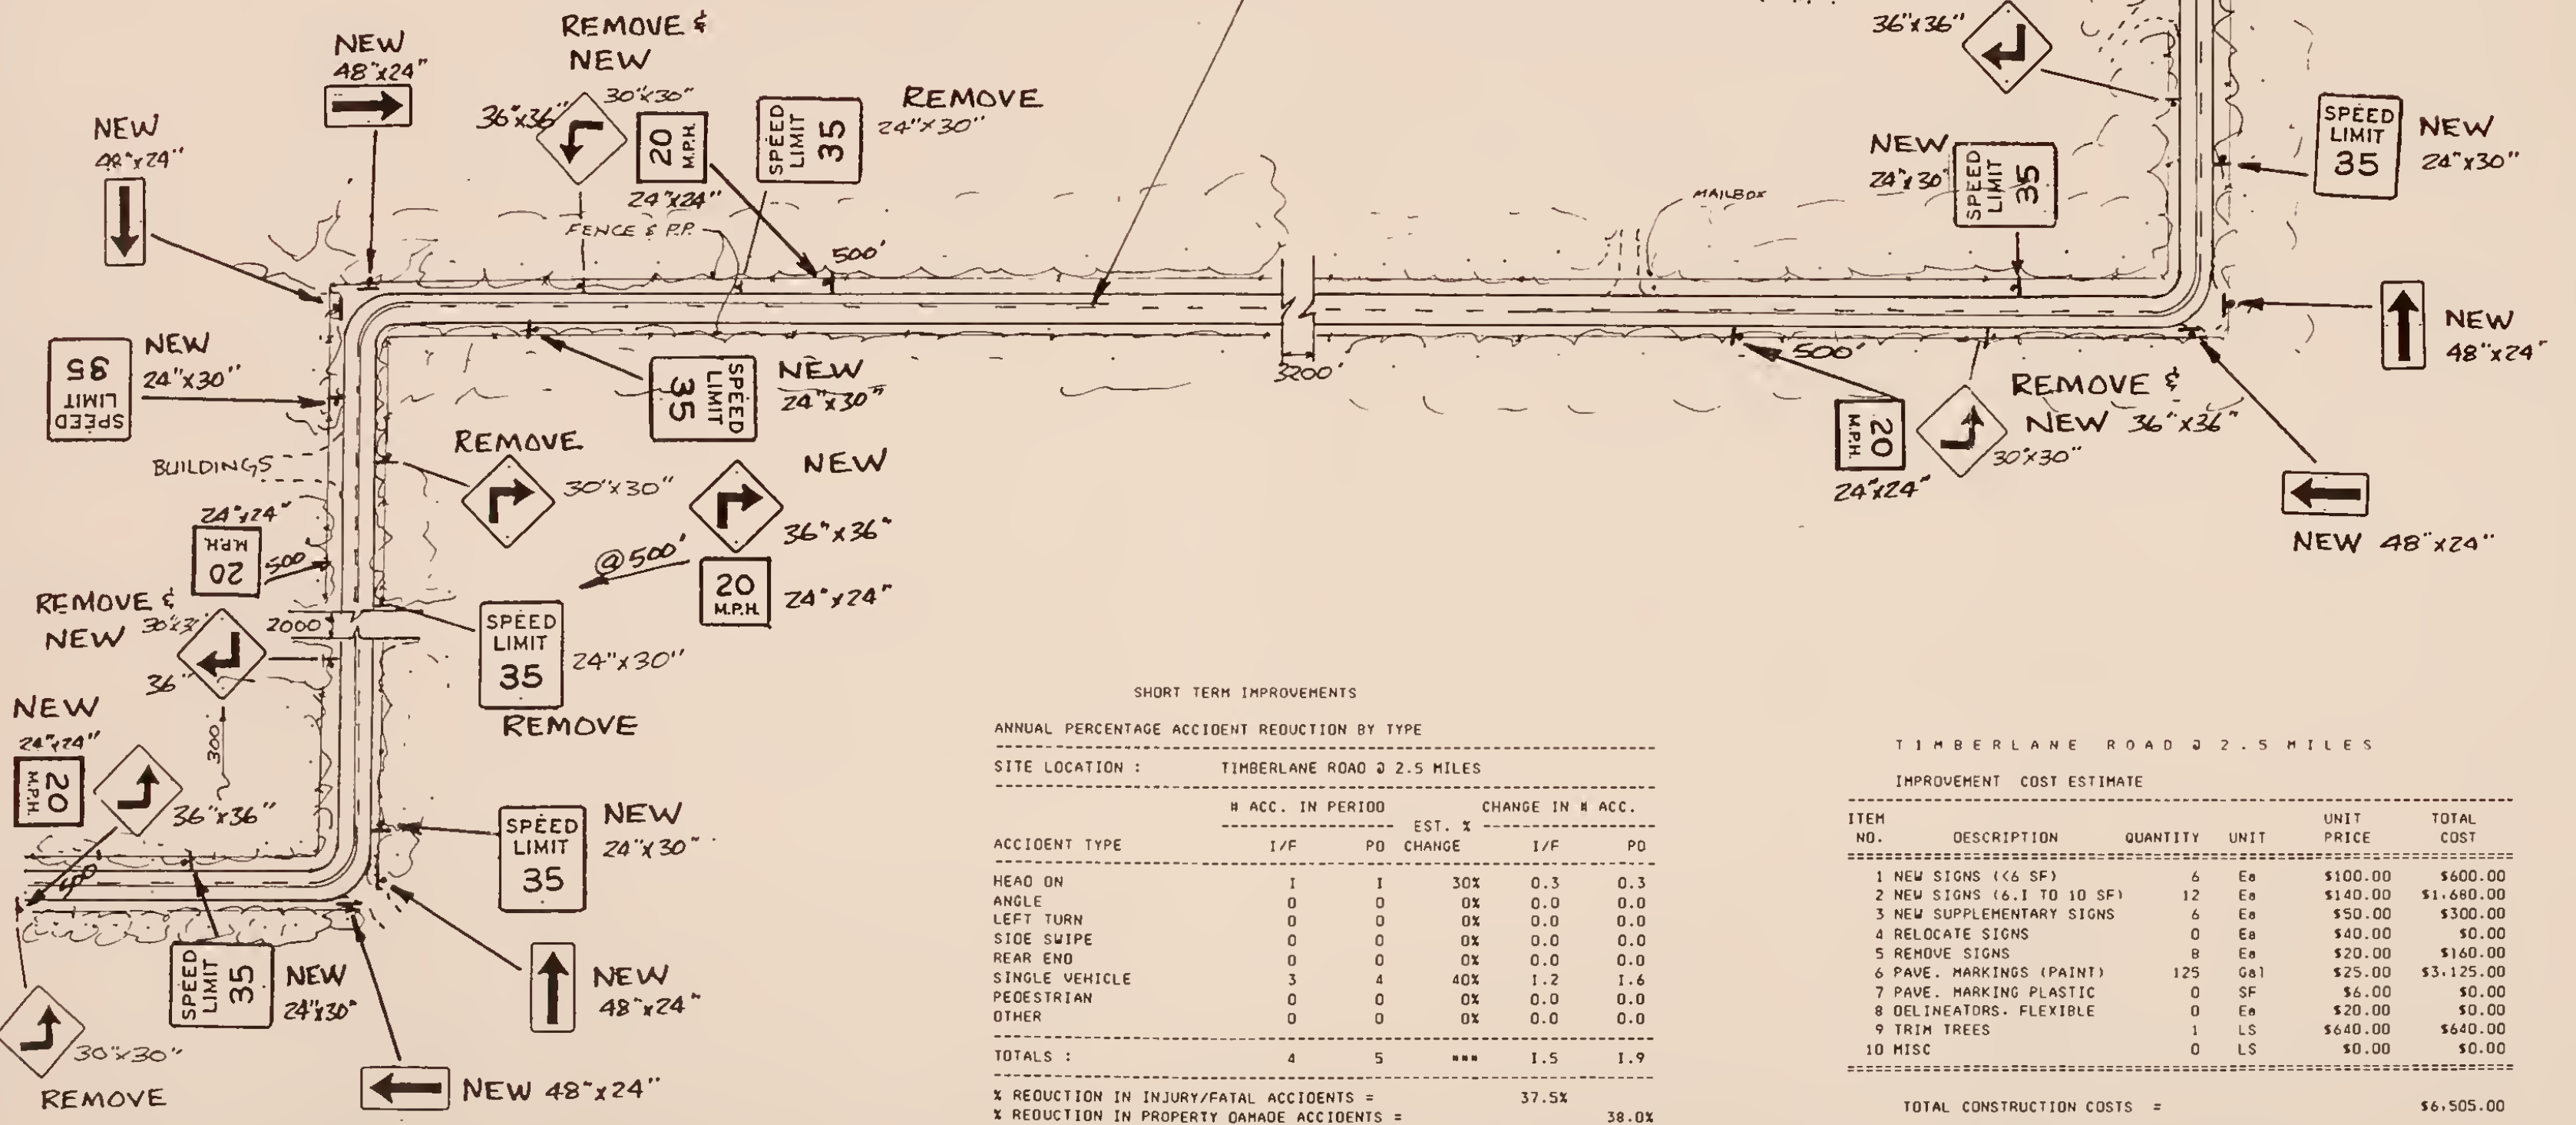
NOTE: CUT TREES & TRIM BRUSH @ INSIDE CURVES & INTERSECTIONS

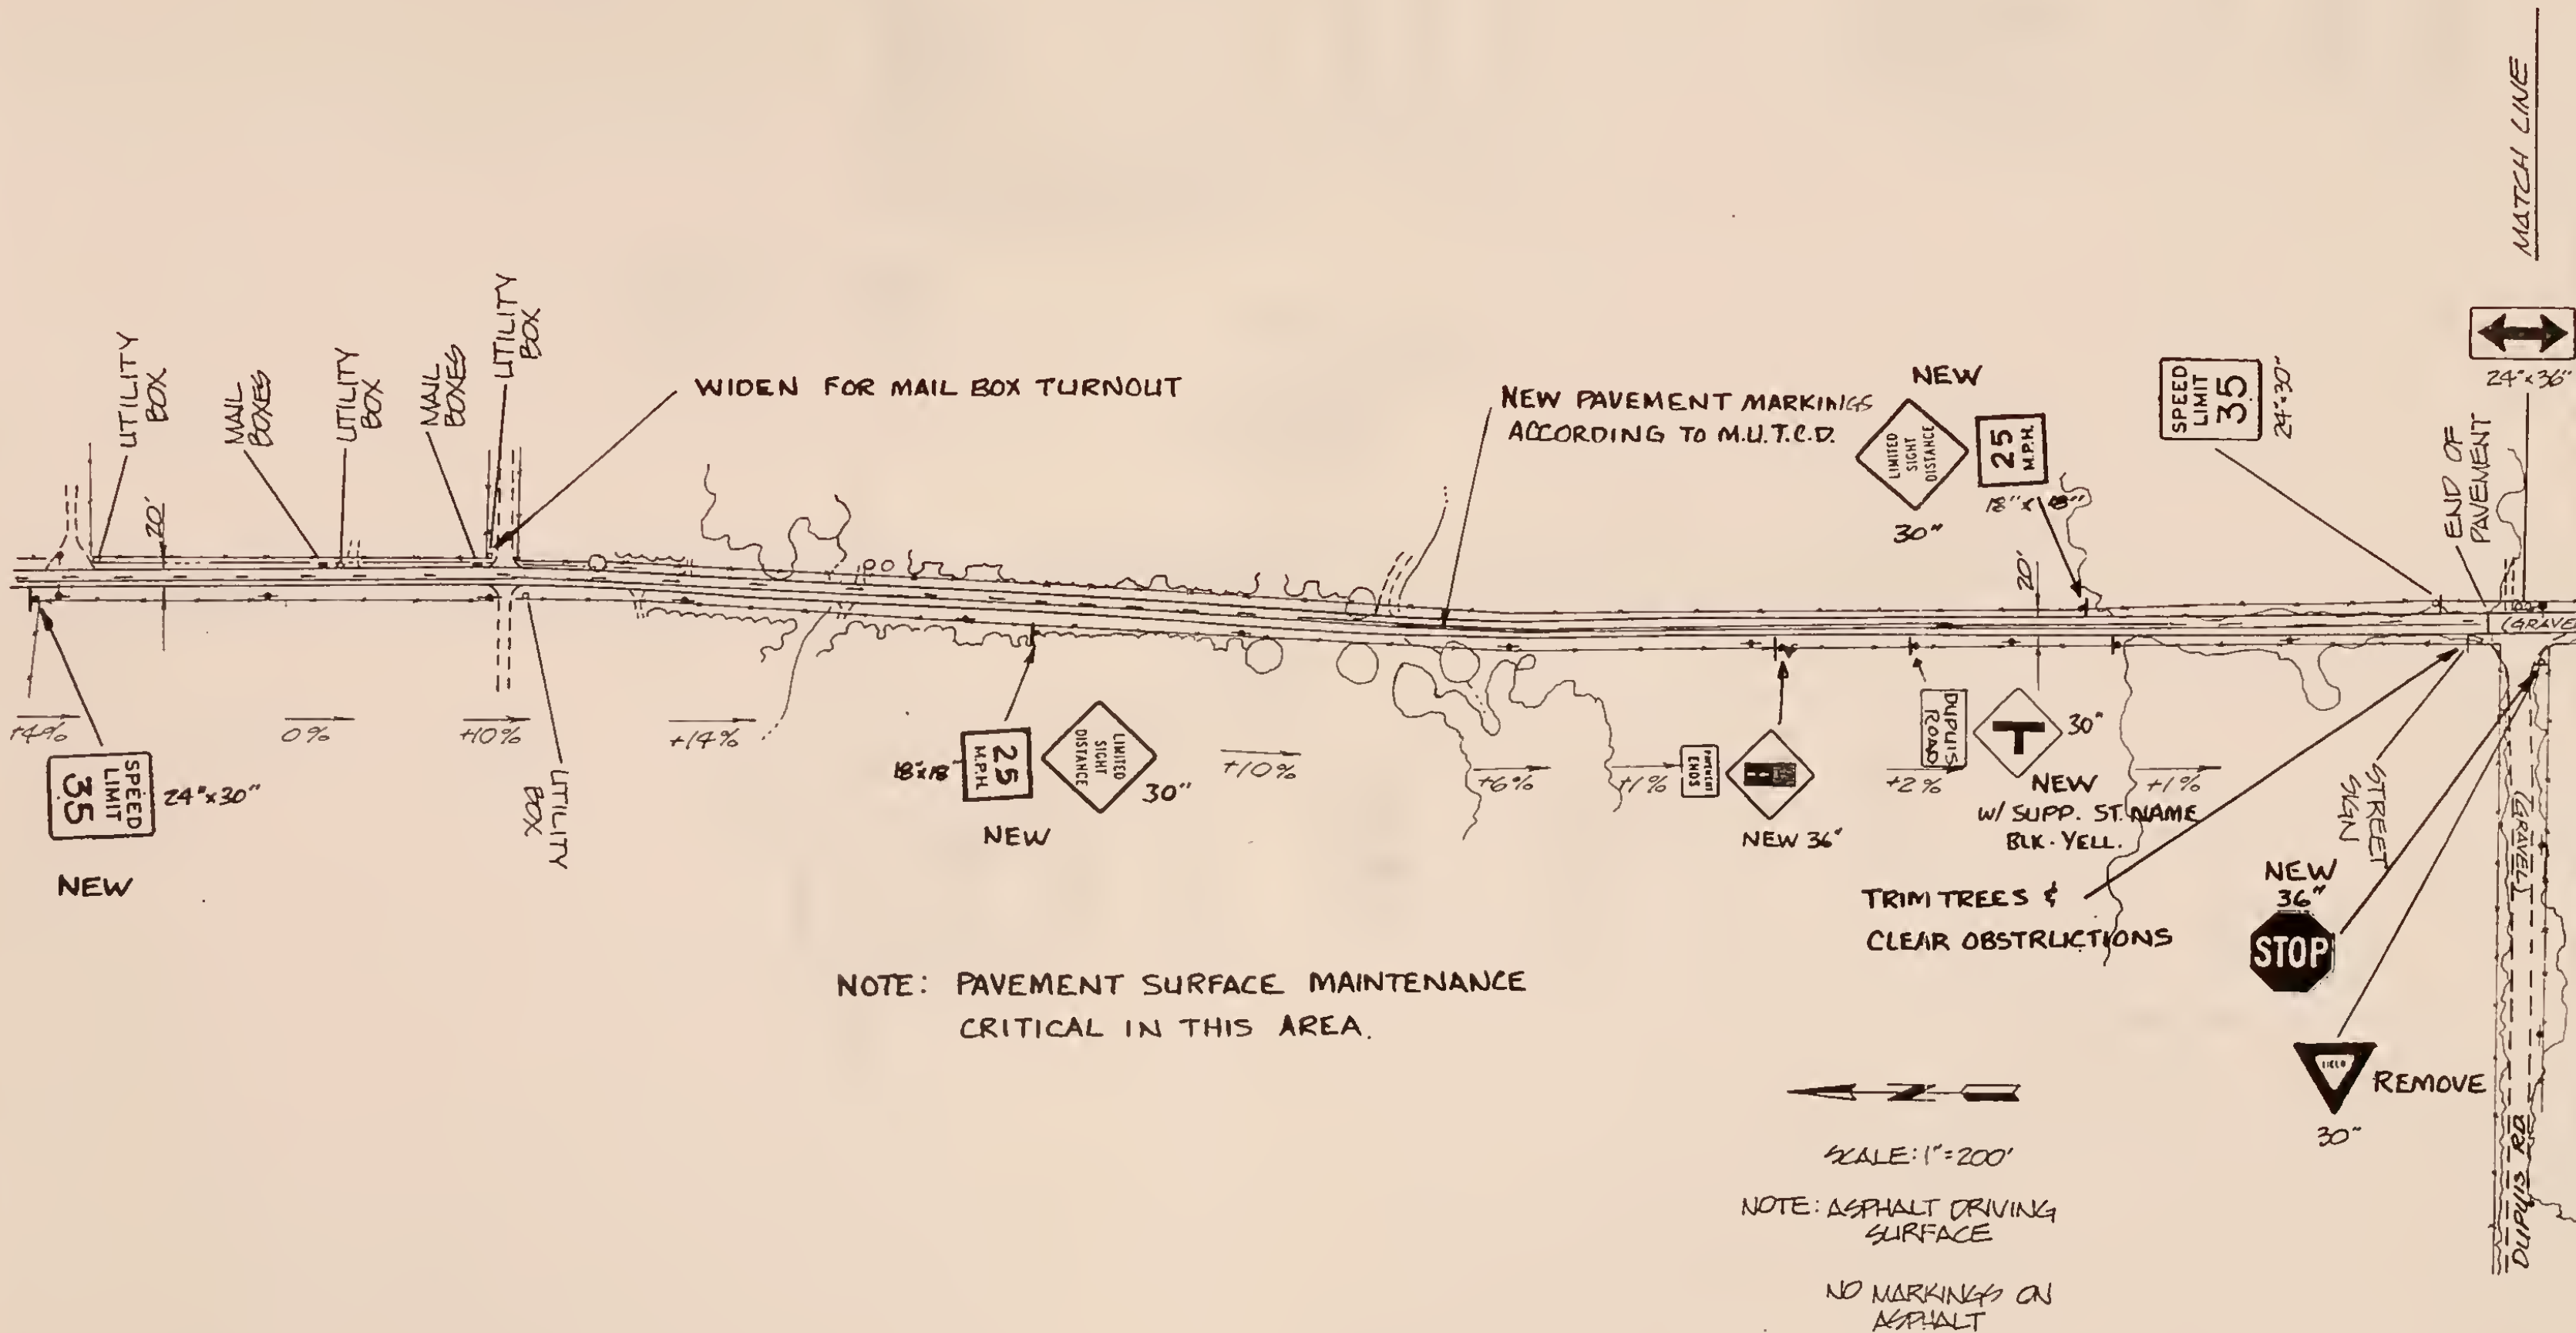
NOTE: PAVEMENT SURFACE MAINTENANCE CRITICAL IN THIS AREA.
